# THE FEASIBILITY ASSESSMENT OF THE EXHIBITION HALL AFTER THE FIRE

The article presents the feasibility assessment and evaluation of technical conditions of basic structural elements of exhibition hall after the fire. The aim of this investigation was to develop the ways for further exploitation of the structure and to evaluate the extent of repairs to be done. The scope of investigation and the detailed methodology for the investigation is presented. Given is the impact of the fire load on the bearing capacity of structural elements. To assess the impact of the damages on the main load bearing beams, besides the standard tests, also the acoustic emission (AE) method was applied.

The subject of this investigation is the construction of the exhibition hall F/G. It is built in the exhibiton complex named Kielce Fair.

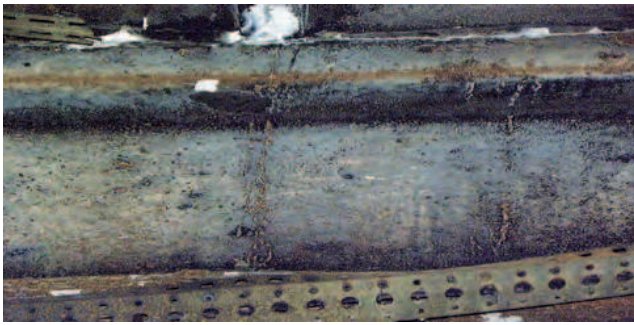
In the area of fire ignitron (Fig. 3) many cracks were discovered in prestressed concrete girders. Cracks were characteristically inclined, running from the support of bearing plates towards their suspension in both directions with 30-60° angles. They were noticed on 4 bearing plates. Besides, on the lower shelves of girders, net fracturing of concrete over its entire surface into the web, was observed (Fig. 4).

Fig. 4. Visible cracks in prestressed concrete girder

W miejscu zarzewia ognia (rys. 3) stwierdzono liczne zarysowania dźwigarów strunobetonowych. Charakterystyczne było ich ukośne zarysowanie od oparcia płyt panwiowych w kierunku zamocowania. Rysy obejmowały obszar ok. 4 płyt panwiowych w obu kierunkach i rozchodziły się pod kątem 30-60°. Ponadto na dolnych półkach dźwigarów zaobserwowano siatkowe spękania betonu na całej ich powierzchni aż do środka (rys. 4).

Taking into consideration diminished operational use and functional values of important structural elements, the new solution had to be found. Proposed was the replacement of structural elements (because of the loss of the bearing capacities) and reconstruction as well because of the loss of 3-D stiffness. Replacement and rebuilding should be carried out first of all in

the area affected by the fire. All the affected bearing elements, including foundation, should be replaced. In the remaining part of the exhibition halls, it was proposed to reinforce elements of the structure and protect against corrosion. It was suggested the implementation of the horizontal reinforcement (i.e. additional strengthening the rigidity of the prefabricated concrete roof as well as the vertical walls – to be reinforced or replaced). That range of work to be done caused the necessity to rebuild (i.e. to modernize) the entire exhibition hall. In this case, the user, confronted with the facts, decided to demolish the entire exhibition hall and to build a new one. The conclusions from this investigation seemed to be the right ones and entirely confirmed. As in the process of disassembly of the structure, after the crane hit the ceiling, the whole structure totally collapsed.
