PROBLEMS OF ENVIRONMENTAL INTERFERENCE IN EMERGENCY REPAIRS OF RAILWAY SECTIONS – A CASE STUDY

Tomasz Sobkowiak

Geomenos Jerzy Sobkowiak, Tomasz Sobkowiak Sp.j., Poznań, Poland

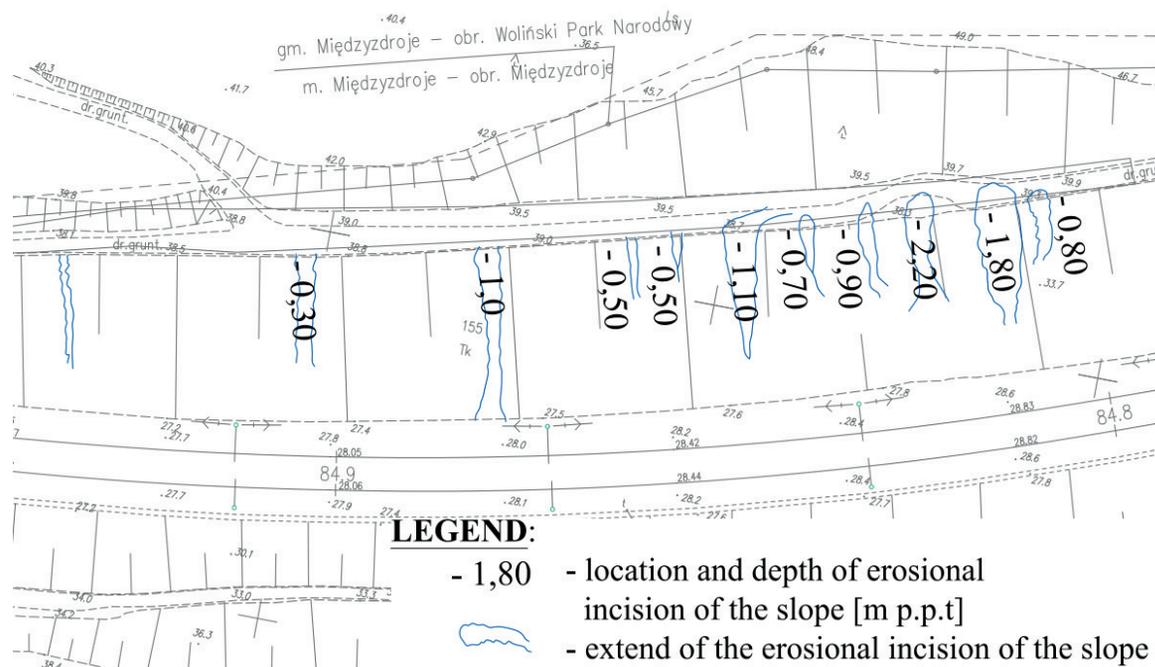
Fig. 1. Map of the railway line section with marked locations, depths, and extents of the erosive cuts on the slope

The slope of the cut on the side of track No. 1 clearly showed signs of deformation in the form of erosive cuts with depths of up to 2.0 meters, and in some sections, the slope geometry was completely destroyed. This condition was a permanent state of the slope, which repeatedly underwent local landslide processes, directly threatening the safety of train traffic on this line [2].

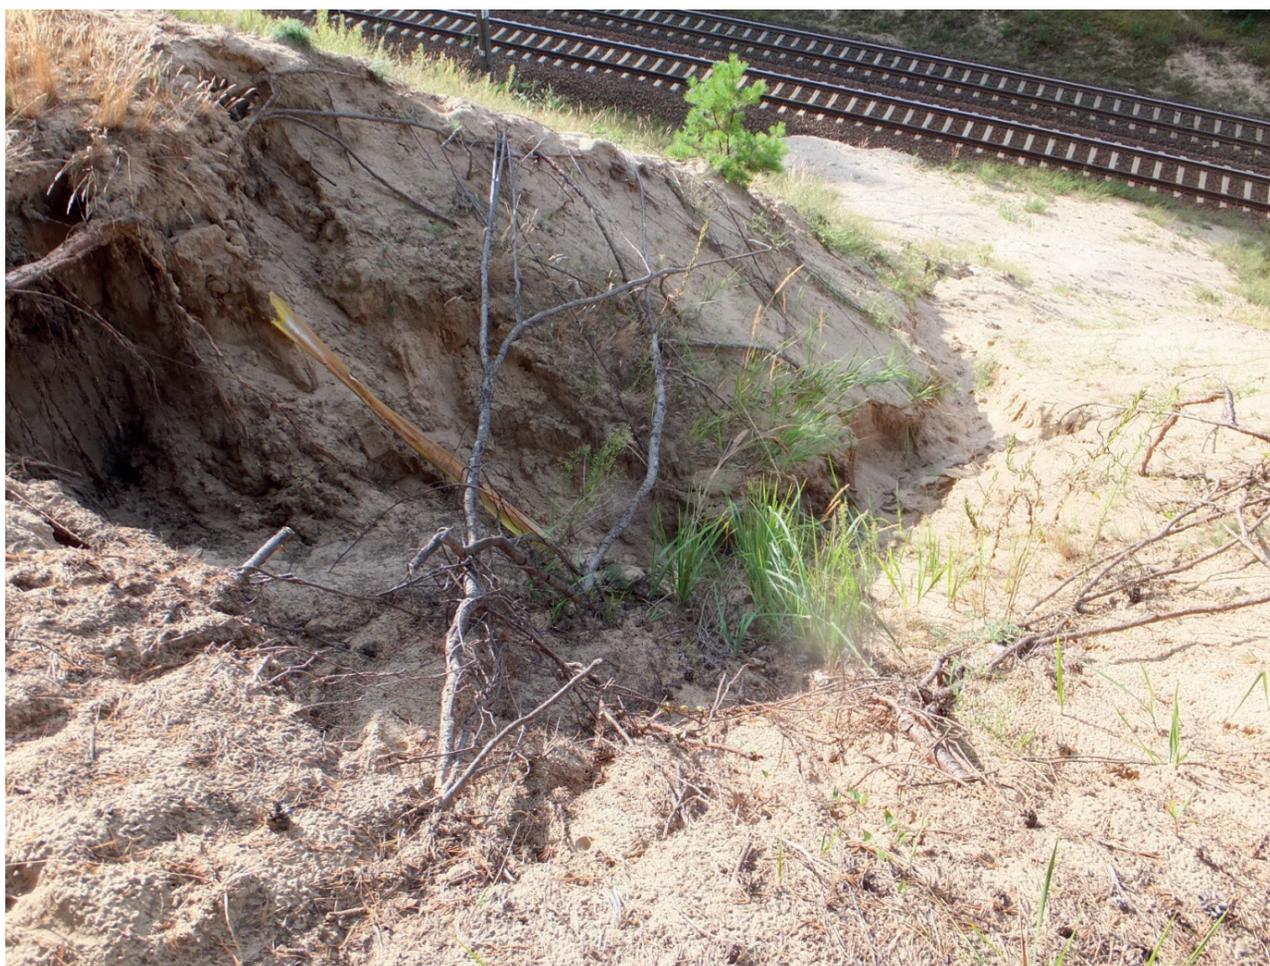
Phot. 1. Erosive funnel with washed-out fine sandy material. Photo by Tomasz Sobkowiak

disintegration) due to surface freezing and thawing, lack of vegetation (southern exposure with intense sunlight, especially in summer), runoff of rainwater, and significantly due to the movement of wild animals on the slope surface. The contribution of wild animals to the destruction of the slope also involved the construction of a system of underground burrows within it. The “channeled” runoff of rainwater in one place and the movement of wild animals specifically in the erosive cuts are the primary causes of slope instability.

1. Reconstructed embankment geometry by filling erosion cuts with soil collected from slope profiling, binding new material with existing embankment through slope benching, and reinforcing the upper slope edge with geocell layers.

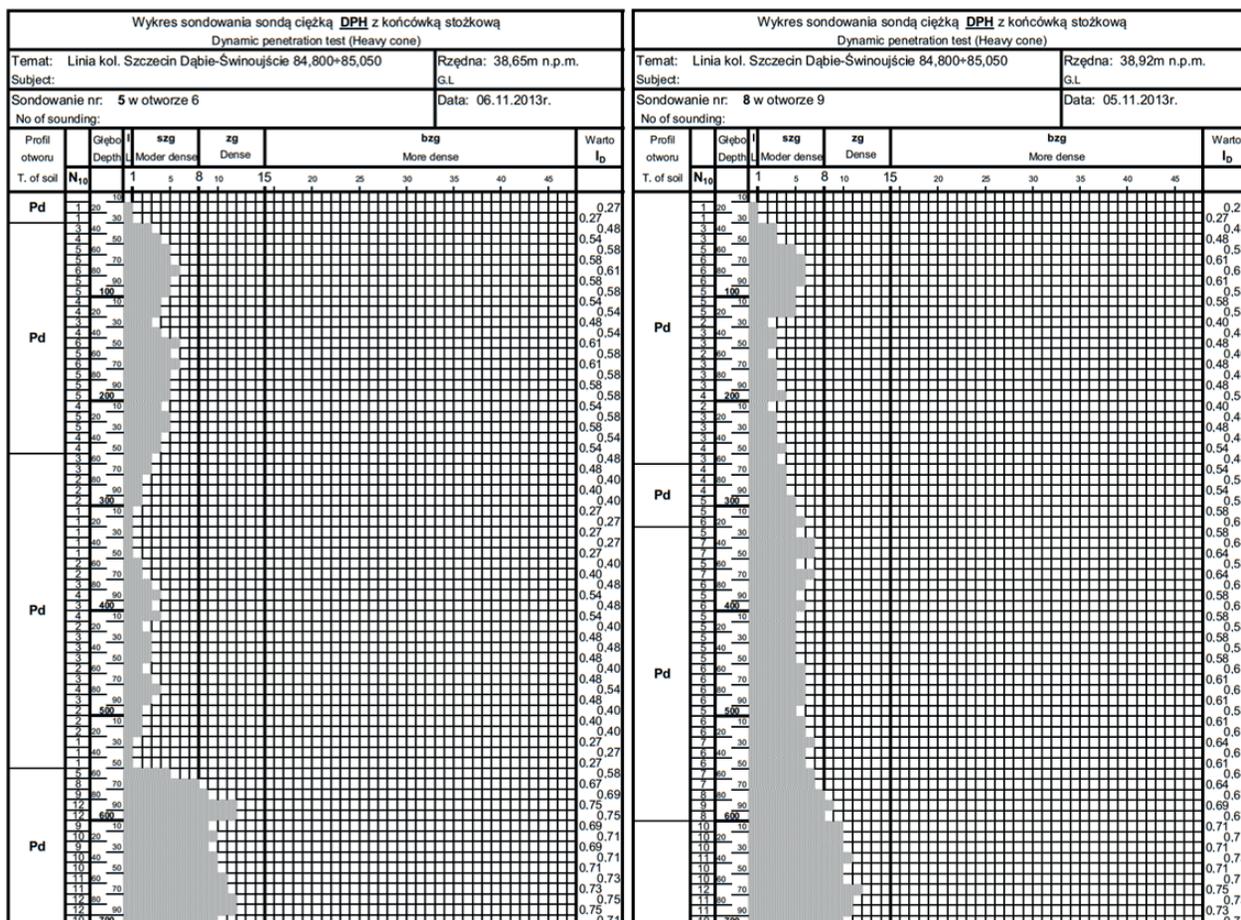
The cut on the examined railway line section, as mentioned, was made within fine dune sands. These sediments are characterised by a very low value of the coefficient of differential grain size C_u , which for these soils is in the range of approx. $C_u = 2.0$. This value of the coefficient of differential grain size C_u indicates that the soil from which the excavation is built belongs to homogeneous, poorly compactible and easily loosened soils. Uniformly graded soils are easily loosened by external impulses such as vibrations and dynamic impacts, and surface water erosion is very intense on the slope surface. Dynamic probing results showed moderately compacted states bordering on loose states to significant depths below the surface.

Fig. 2. Dynamic probing (DPH) test charts

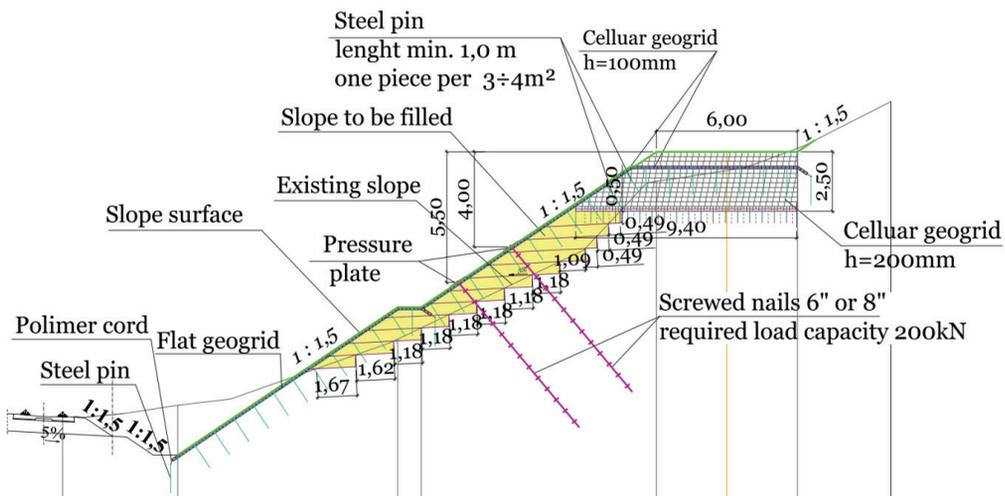
Fig. 3. Example cross-section from the construction project of the cut slope

2. Implemented soak wells to manage runoff from the highland surface towards the cut.
3. To protect the slope surface from exogenous processes and the destructive impact of migrating animals, a flat geogrid and a cellular geogrid with a height of 100 mm were selected, fastened to the slope surface using a polymer rope system with polymer pins. This solution did not guarantee mechanical reinforcement of the slope.
4. Used CHANCE screw anchors without injection for mechanical reinforcement, marking a first in Poland's railway lines.
5. Completed the repair by restoring drainage along the tracks adjacent to the repaired slope.

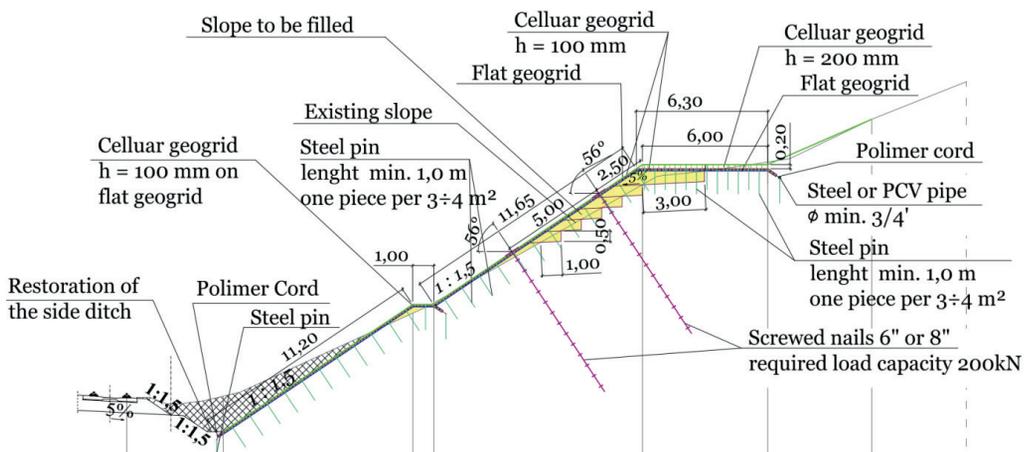
Fig. 4. Example cross-section from the construction project of the cut slope

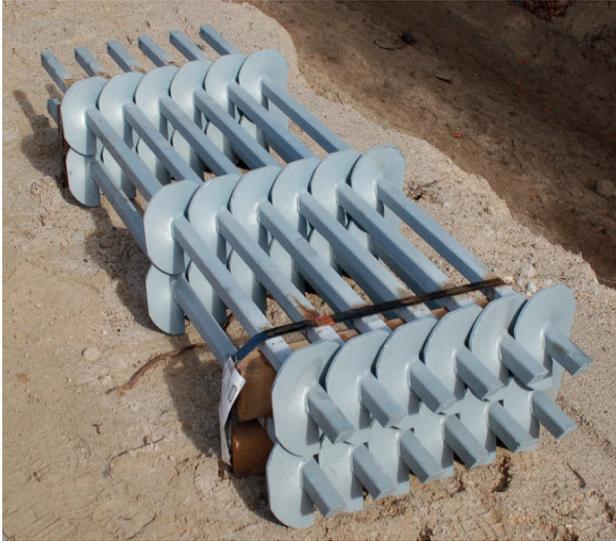
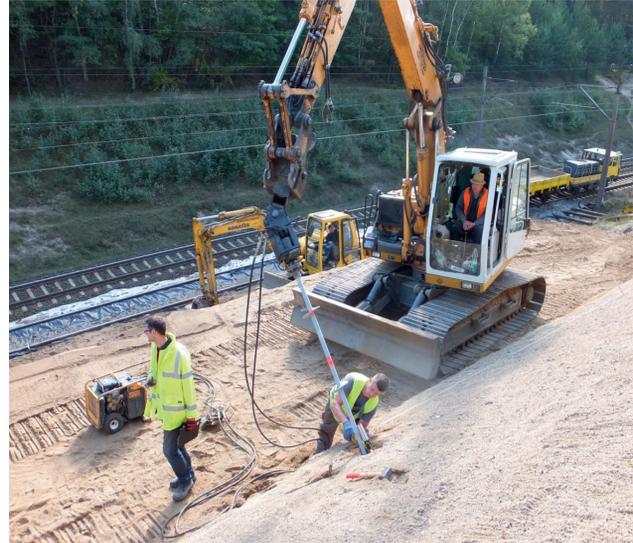
Phot. 2. Installation of CHANCE non-injection nails. Photo by Tomasz Sobkowiak

Constraints resulting from the agreements between the investor and the WPN management obligated the contractor to use nails that do not introduce chemicals into the natural soil. The Polish construction market primarily offers injection nails and anchors proposed by various manufacturers. The essence of these reinforcement systems is the introduction of a chemical injection (mainly cement-based) into the natural soil to bind the soil with the drill rod, increasing friction, sealing, and thereby achieving the desired load-bearing capacity of the nail/anchor. To meet the environmental requirements imposed on the design solutions, it was decided to use, for the first time on railway lines in Poland, the American

technology of CHANCE screw-in nails. Organizing the entire screwing process required numerous procedures, as the selected technology mandated real-time control of the anchorage strength values. The screwing of the nails had to be conducted using factory-calibrated and equipped heads. The second significant problem that had to be addressed was the condition of obtaining a warranty for this technology from the producer of CHANCE screw-in nails. Supervision of the works had to be carried out by a person with credentials granted by the manufacturer. Due to the novelty and uniqueness of this technology in Poland, the author of this article, along with several other individuals, urgently attended the first appropriate course in Poland and obtained the manufacturer's certification for designing and supervising the installation of the CHANCE system.

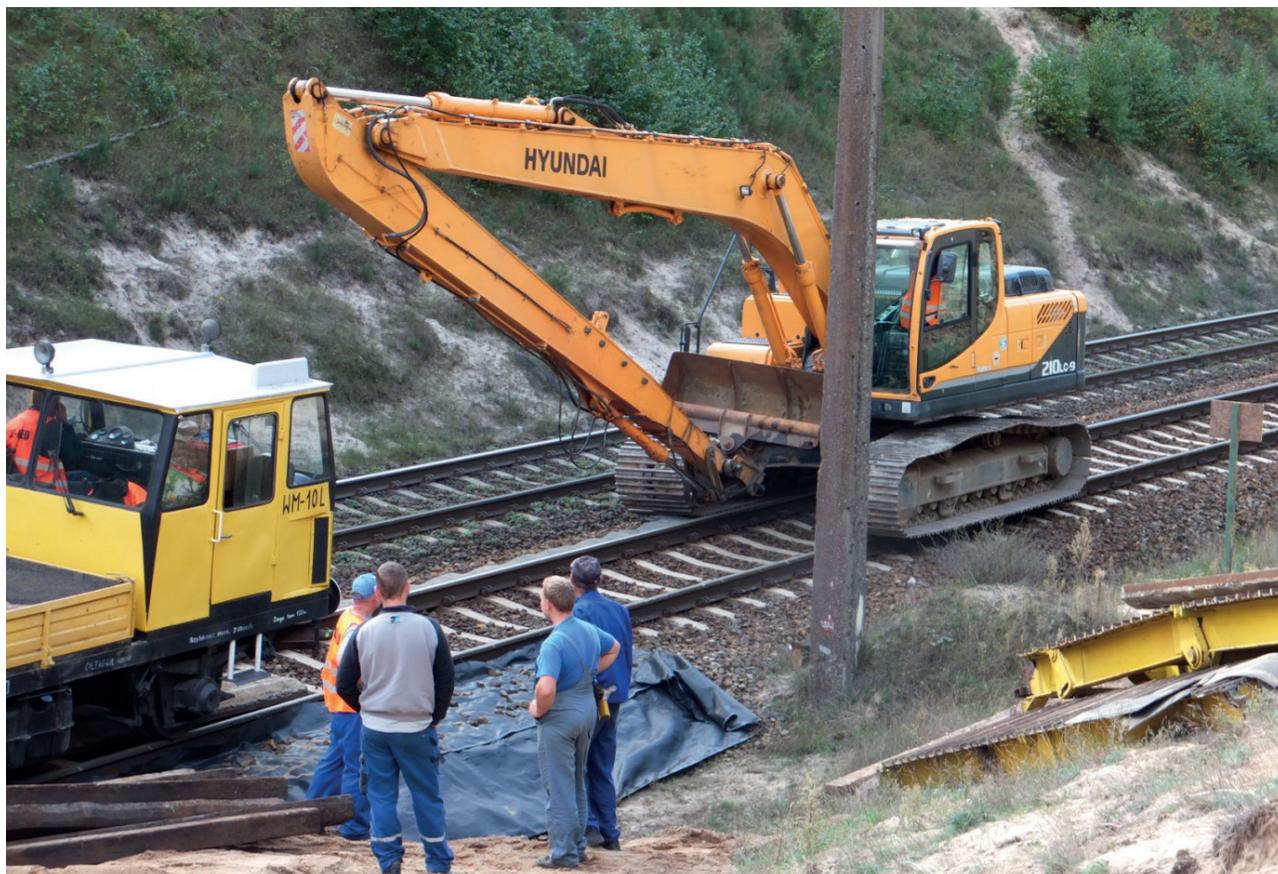
Phot. 3. Transport of a crawler excavator on a track temporarily out of service. Photo by Tomasz Sobkowiak

According to the agreements, the park's internal roads could only serve as access routes for small construction equipment. Building materials, construction facilities, as well as large construction equipment, had to be delivered to the construction site by rail using railway platforms. Implementing the repair works according to the accepted project required the use of several crawler excavators, including the "Long" type, making logistics a significant challenge. For the entire duration of the works, the track adjacent to the damaged slope was taken out of service, along with the deactivation and partial dismantling of the electric traction. Temporary construction using geotextile and old wooden railway

sleepers was necessary to protect the railway surface. On the adjacent track, the train speed was reduced along the length of the section where the construction works were being carried out. Preparing the working platform for the crawler excavator required building an additional earth buttress of appropriate width along the entire section of the works. Organizing the construction site and delivering equipment and materials was time-consuming, logistically challenging, and costly.

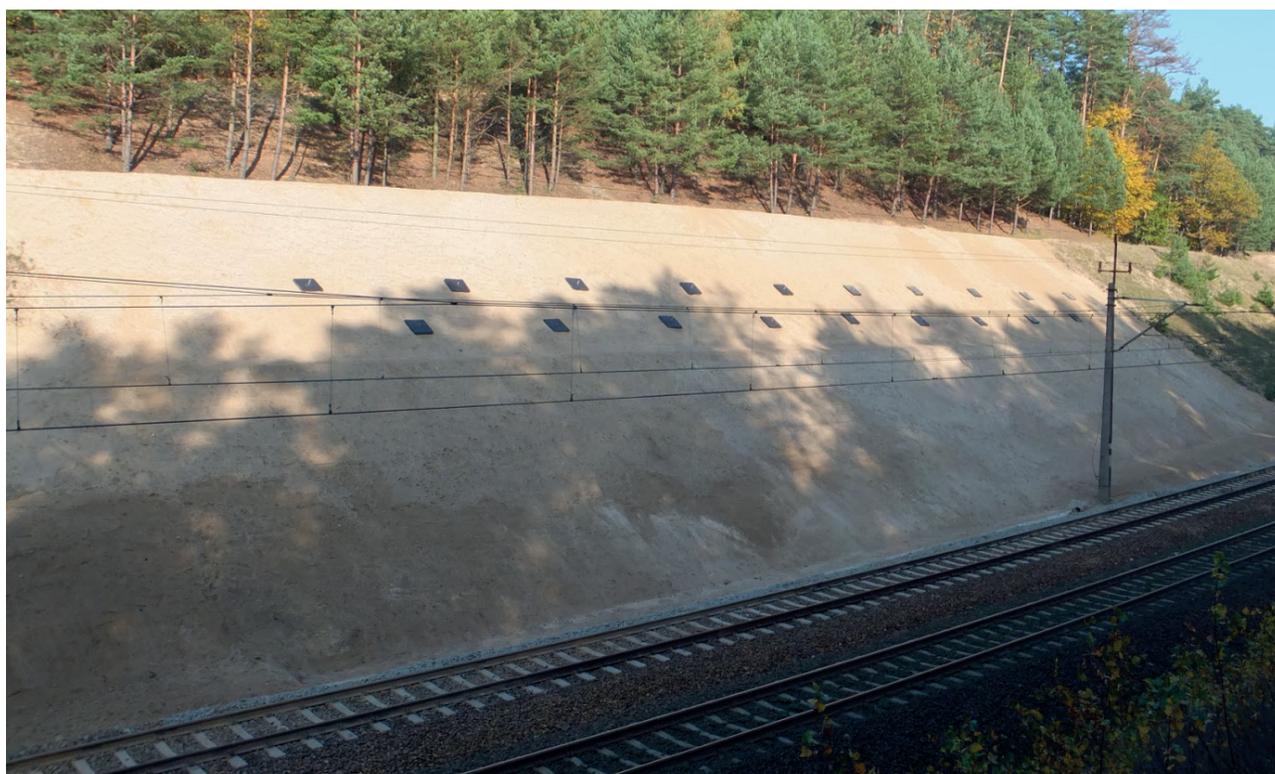
Phot. 4. Section of the ditch slope after completion of repair works. Photo by Tomasz Sobkowiak

Providing seeds of grasses native to the park by Wolin National Park proved to be absolutely impossible, as the Park did not have such seeds, and selecting and purchasing the correct species composition and proportions of grasses was unfeasible. Despite the engineering awareness of an imperfectly completed repair, the requirements of the agreement between the investor and the park management were met by leaving the slope unseeded, hoping that nature would eventually replenish this deficiency on its own.
