ASSESSMENT OF THE POSSIBILITY OF USING THE EXISTING FOUNDATIONS FOR THE CONSTRUCTION OF A STEEL SILOS

Stanisław Plechawski*
Design-Construction Office Planex Zamość

Abstract

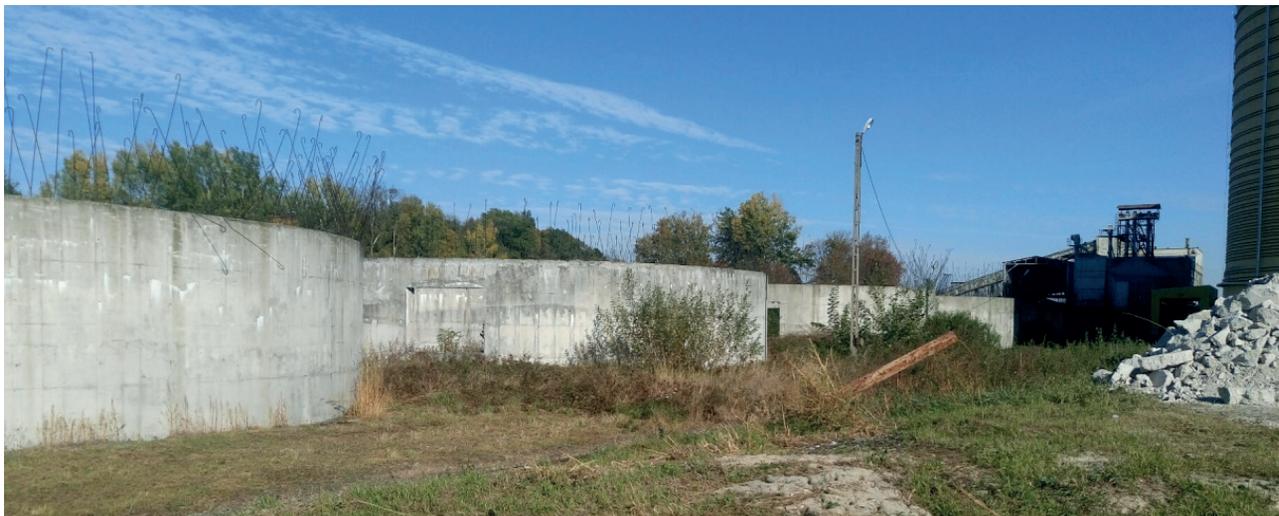
The reinforced concrete foundations of the seven silos, made in the early 1990s, are located in the north-west part of the plant. Originally, the construction of reinforced concrete silos for rapeseed grain was planned on the foundations. Due to the change in the socio-economic situation, only the foundations in question were constructed (Fig. 1).

Fig. 1. General view of the foundations for the silos from the south

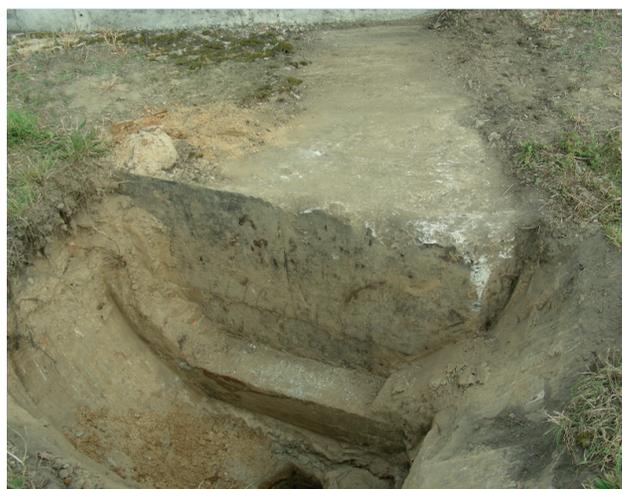
In the open pit, the foundation of the silo foundation was found on a bedding made of fine sand and crushed stone, laid on the native soil – medium-compacted fine sands with lamination of clay sand. Foundation condition – good (Fig. 2).

Fig. 2. The exposed foundation plate No. 7

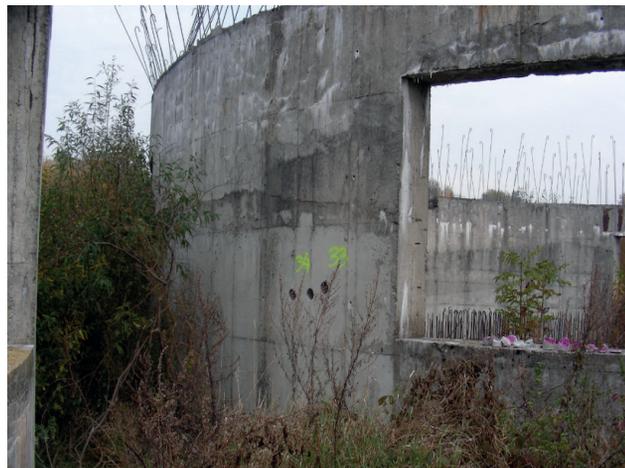
1. Visible white efflorescence on the surfaces of the concrete plinths walls of the foundations (Fig. 3 and Fig. 5).

Fig. 3. Fragment of foundation No. 6. On the left, a narrow fragment of foundation No. 7

2. Concrete scratches and cracks – especially above the openings intended for the passage of tunnels in the plinth walls of the foundations – Figure 3. On the left – a narrow fragment of the foundation No. 7 – visible delamination of concrete along the corroded reinforcing bar at the top.
3. Degraded upper surface (crown) of all foundation walls – Figure 5.

4. Traces of breaks in concreting: no bonding of the concrete placed earlier (lower) with the concrete placed later (Fig. 3 and Fig. 5).

Insufficient uniformity of concrete and large spread of compressive strength could be caused by improper compaction of concrete or even lack of compaction, which seems to confirm the lack of bonding of concrete placed earlier with concrete placed later (Fig. 3 and Fig. 5).

The scope of necessary repair work is given in the expert opinion. Overall, it included: cleaning the entire surface of the walls and foundation slabs after the foundations were discovered; hydro-sandblasting of the concrete substrate; forging the crown of foundation walls on the thickness of the layer of corroded concrete and reinforcing steel; forging a layer of corroded concrete in places of necessary repairs along corroded and exposed reinforcing bars and under them, abrasive blast cleaning from corrosion of exposed external rebars; anti-corrosion protection of cleaned reinforcing steel; reconstruction of the foundation wall crown (concreting); substrate re-profiling: filling the cavities in concrete with a repair mortar and leveling the surface; putting of concrete repair layers; execution of anti-moisture insulation in some of the walls subject to be back filled again with soil.

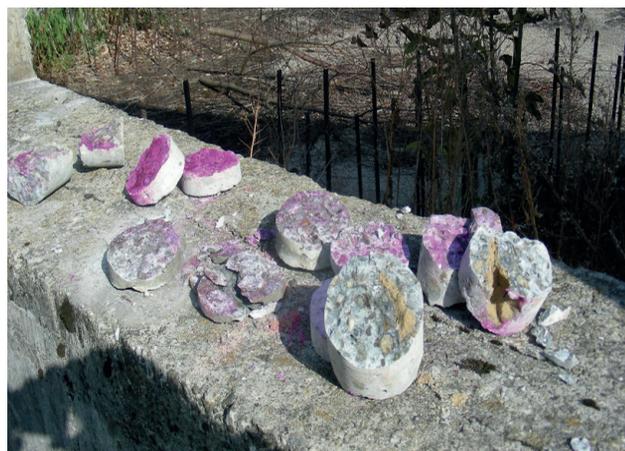
Fig. 4. Delaminated (impacts on concrete) samples. Right: a sample with poorly mixed concrete components – visible aggregate (sand) inside

- Discoloration – a darker color of the concrete surface, observed especially in the area of shading foundations with the existing, adjacent silos – Figure 5.
- Exposed reinforcing bars, vertical and horizontal, intended for further concreting of the structure, with visible surface corrosion – Figure 3 and Figure 5.
- A visible delamination of concrete in the structure (Fig. 7) and a very easy delamination of concrete samples taken from the structure during impact tests (samples hitting concrete – Fig. 4).

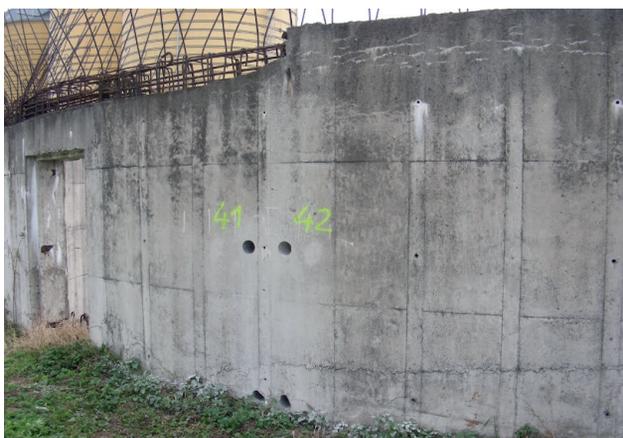
Fig. 5. Fragment of foundation No. 7 – visible salinity in concrete cracks, exposed corroded reinforcing bars and a trace of a break in concreting: no bonding of concrete placed earlier (lower) with concrete placed later. Darker color of the concrete surface. Degraded upper surface of the foundation wall

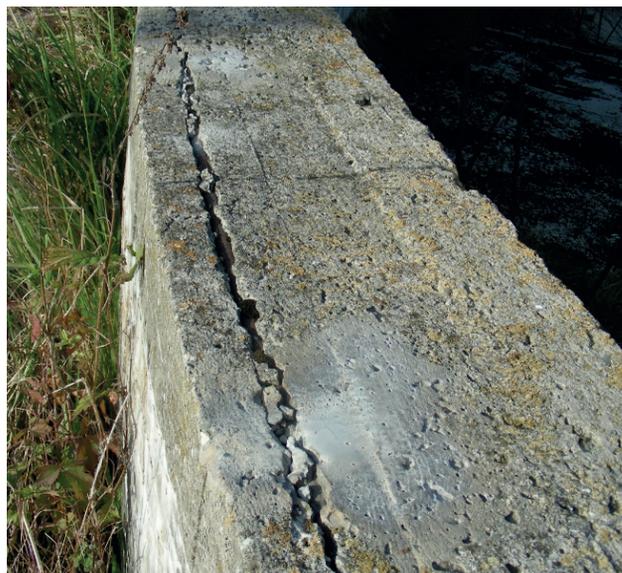
The reaction product (iron oxide – rust), increasing its volume, generates stresses causing concrete cracking and even delamination of concrete along corroded reinforcing bars. The situation shown in Figure 7 is repeated in practically every hole in the foundation walls, both on the lower surface, as well as on vertical and upper surfaces.

Fig. 7. Concrete delamination along a corroded reinforcing bar

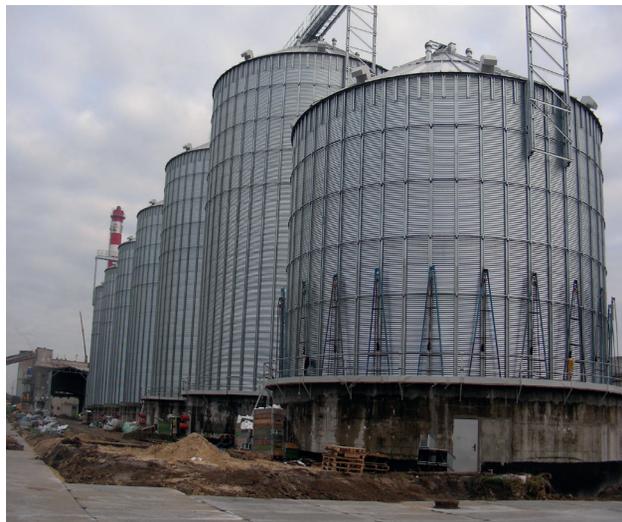
The last, seventh steel silo is mounted on the foundations – the lowest one in Figures 8 and 9.

Fig. 8. General view of the silos from the west

Fig. 9. General view of the silos from the west
