NUMERICAL MODELLING OF INTERLAYER ADHESION IN THE LAYER OF RECYCLED MATERIAL WITH THE USE OF THE LEUTNER APPARATUS AND COMPUTED TOMOGRAPHY SCANNING

ASSESSMENT OF THE POSSIBILITY OF USING THE EXISTING FOUNDATIONS FOR THE CONSTRUCTION OF A STEEL SILOS

QUESTIONNAIRE SURVEY OF THERMAL SENSATIONS IN THE LARGE LECTURE ROOM

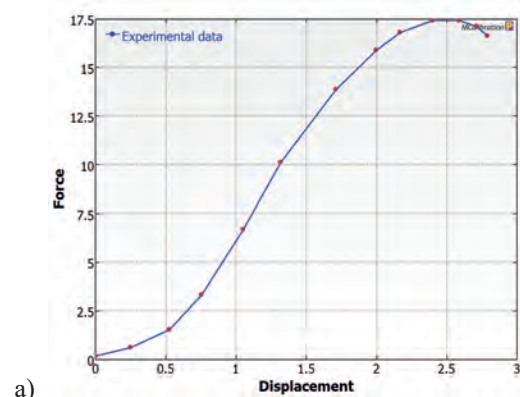
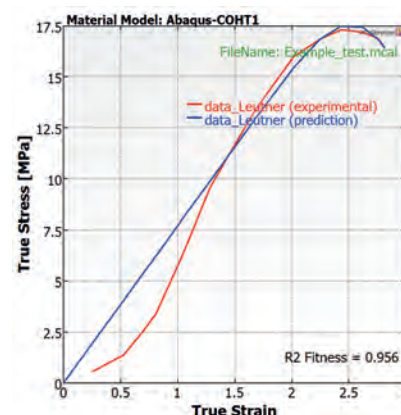
The parameters of the cohesion contact model were obtained on the basis of the tests with the use of the Leutner apparatus. Identification of the parameters of the cohesion contact model was performed using one of the tests whose course was closest to the average value in the series of tests. Unfortunately, the available software does not have the feature to generate a digital file with the data. Nevertheless, the results of the course of the cohesive failure require mathematical formalisation. Therefore, the results obtained using the Leutner apparatus were interpolated from the photograph recording the course of the measurement using a unique calibration method with the use of graphic files [19]. The results obtained during the test using the Leutner apparatus are shown in Figure 5a.

Fig. 5. Identification of the cohesion contact model parameters: a) mapping the course of the graphic file examination; b) calibration of the cohesion contact model based on the Leutner test

The results are presented in Figure 5a were subjected to further analysis to identify the parameters of the cohesion contact model, including the stiffness values contained in the matrix K (1) and the nominal shear stress S . The linear criterion of the maximum stress ratio was adopted as the failure criterion [3]. For the full identification of the cohesion contact model parameters and their transfer in the form of a script, using the “spline” type interpolation function was required (Fig. 5b). As a result of the process of adjusting the interpolation-type function to the results of the experiment, the parameters of the cohesion contact model were obtained at the coefficient of determination at the level of $R^2 = 0.956$ – the parameters are given in Table 1.

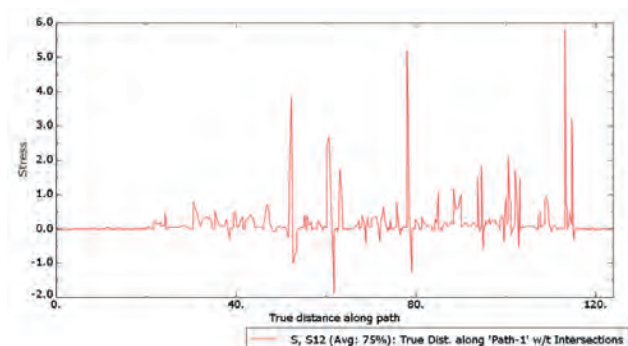
The analysis was supplemented by the estimation of the shear stresses caused by the delamination force in the contact zone between the MMA and MACA

Fig. 11. The shear stress distribution in the contact zone (S12) along the length of the RCM-FB layer sample

It should be noted that, according to the Polish requirements, [15] the maximum shear stress between the bonding layer and the substructure that does not result in loss of interlayer adhesion, should be <0.7 MPa. No pressure force is applied by the Leutner apparatus, so the friction effect between the grains is of less importance. During the Leutner test, friction is caused mainly by wedging of the aggregate obtained during the compaction of the binding layer on the base course. Nevertheless, the analysis presented in the numerical simulation is a reliable representation of this state, where the wedging effect was initiated by the applied vertical deformation ($U = 0.5$ mm). When observing the course of the shear stress in the contact zone of the layers, it should be noted that there are several local areas where the shear stress exceeded 0.7 MPa. Shear stress $>$ higher than 2.0 MPa was developed in at least 5 points. It

indicates a very high value of the delamination force, which will negatively affect the further degradation of the connection. The singular areas where such high shear stress occurred were located in the aggregate-aggregate points of contact between the layers and where their overlapping occurred. It should be noted that the test with the use of Leutner apparatus allows obtaining the averaged value of stress between the layers. The shear stress reached the value of 0.7 MPa in many areas. Therefore, it confirms the correctness of the criteria adopted in Polish regulations for the biding layer-base course systems.

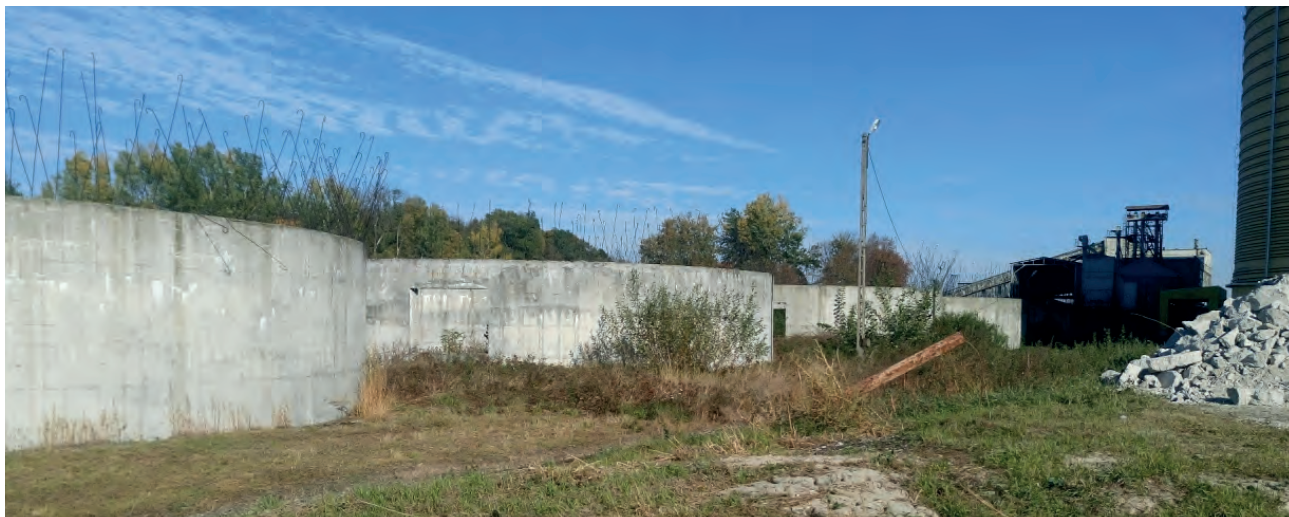
The reinforced concrete foundations of the seven silos, made in the early 1990s, are located in the north-west part of the plant. Originally, the construction of reinforced concrete silos for rapeseed grain was planned on the foundations. Due to the change in the socio-economic situation, only the foundations in question were constructed (Fig. 1).

Fig. 1. General view of the foundations for the silos from the south

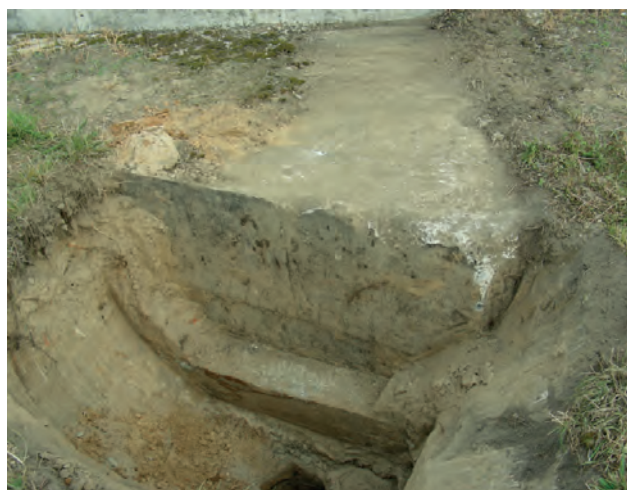
In the open pit, the foundation of the silo foundation was found on a bedding made of fine sand and crushed stone, laid on the native soil – medium-compacted fine sands with lamination of clay sand. Foundation condition – good (Fig. 2).

Fig. 2. The exposed foundation plate No. 7

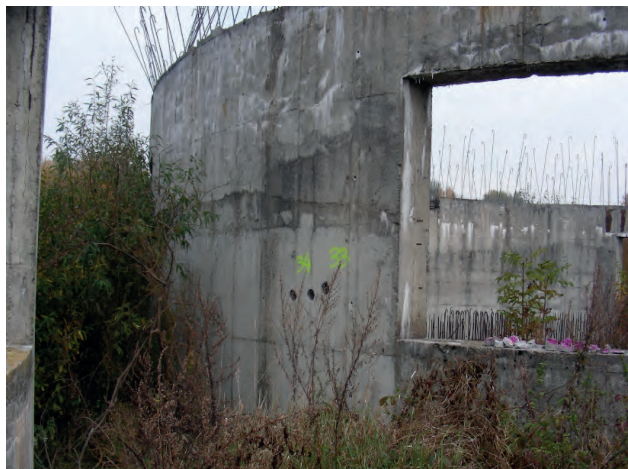
1. Visible white efflorescence on the surfaces of the concrete plinths walls of the foundations (Fig. 3 and Fig. 5).

Fig. 3. Fragment of foundation No. 6. On the left, a narrow fragment of foundation No. 7

2. Concrete scratches and cracks – especially above the openings intended for the passage of tunnels in the plinth walls of the foundations – Figure 3. On the left – a narrow fragment of the foundation No. 7 – visible delamination of concrete along the corroded reinforcing bar at the top.
3. Degraded upper surface (crown) of all foundation walls – Figure 5.

4. Traces of breaks in concreting: no bonding of the concrete placed earlier (lower) with the concrete placed later (Fig. 3 and Fig. 5).

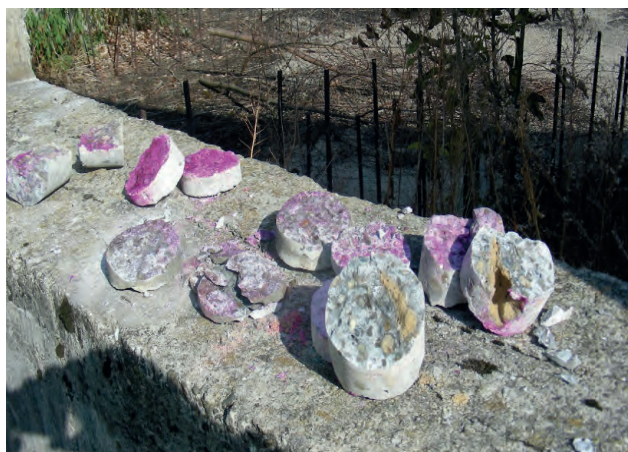
Fig. 4. Delaminated (impacts on concrete) samples. Right: a sample with poorly mixed concrete components – visible aggregate (sand) inside

- Discoloration – a darker color of the concrete surface, observed especially in the area of shading foundations with the existing, adjacent silos – Figure 5.
- Exposed reinforcing bars, vertical and horizontal, intended for further concreting of the structure, with visible surface corrosion – Figure 3 and Figure 5.
- A visible delamination of concrete in the structure (Fig. 7) and a very easy delamination of concrete samples taken from the structure during impact tests (samples hitting concrete – Fig. 4).

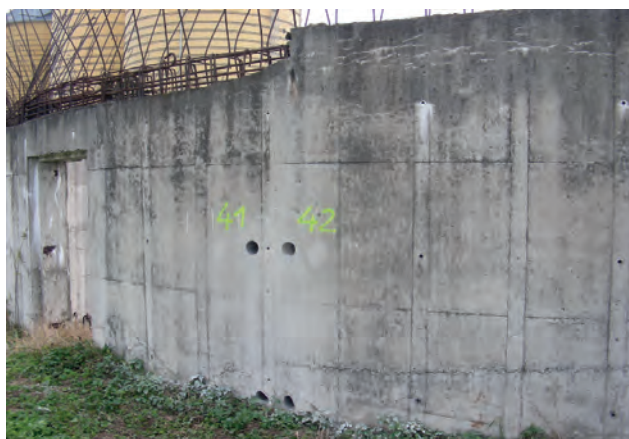
Fig. 5. Fragment of foundation No. 7 – visible salinity in concrete cracks, exposed corroded reinforcing bars and a trace of a break in concreting: no bonding of concrete placed earlier (lower) with concrete placed later. Darker color of the concrete surface. Degraded upper surface of the foundation wall

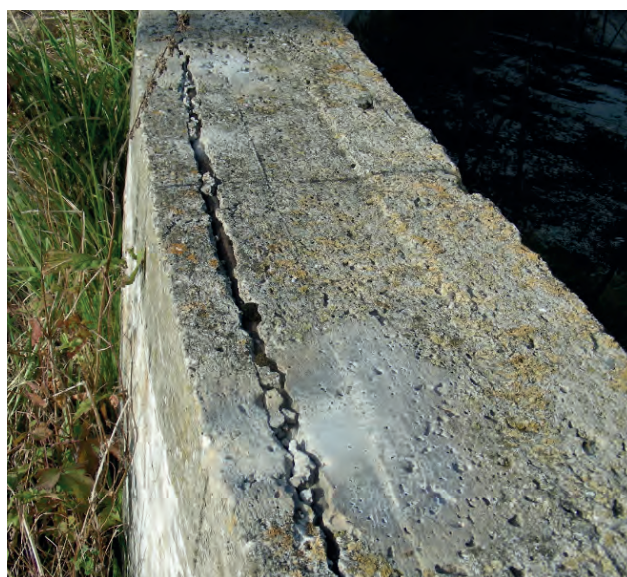
Fig. 7. Concrete delamination along a corroded reinforcing bar

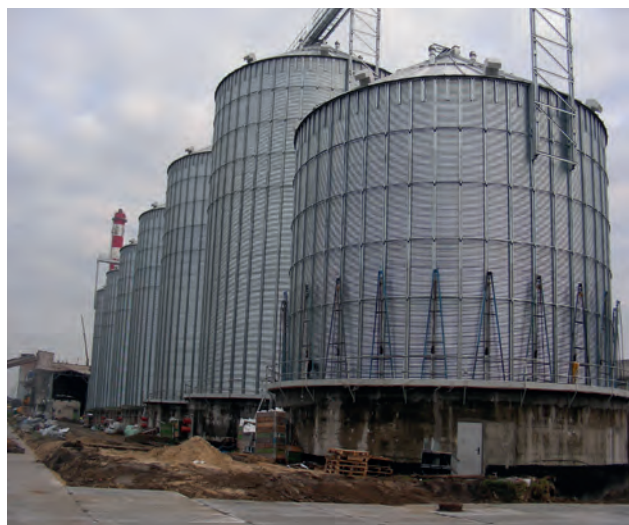
The last, seventh steel silo is mounted on the foundations – the lowest one in Figures 8 and 9.

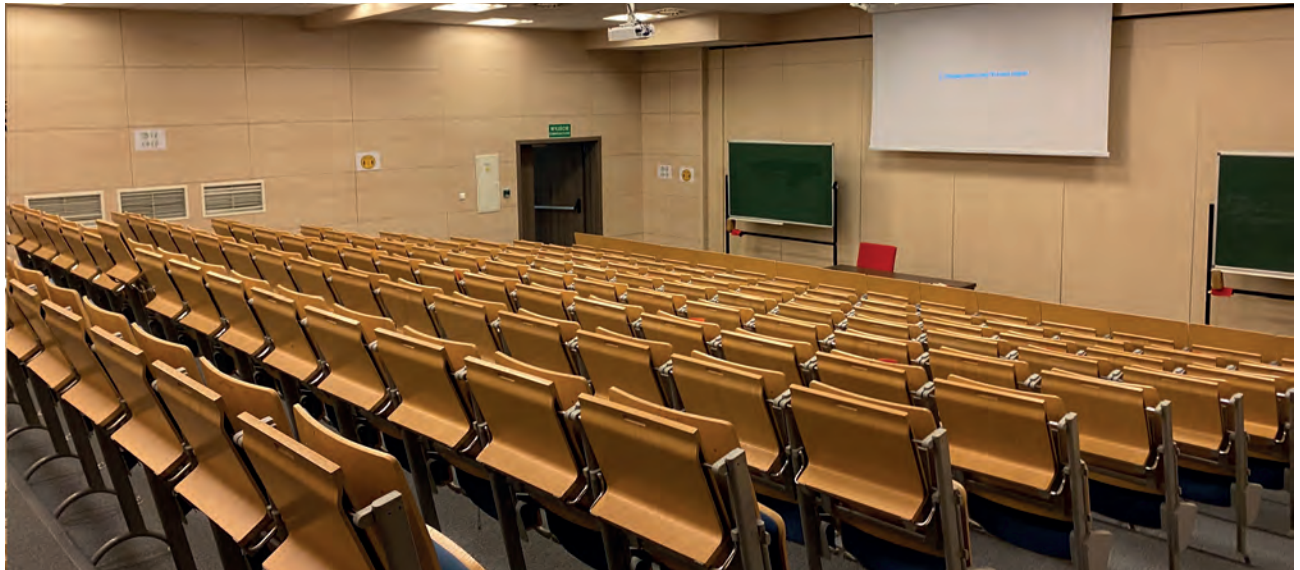
Fig. 1. Lecture room where the tests took place

The study was conducted in one of the main lecture halls of the Kielce University of Technology, on a group of 69 students (Fig. 1). For this purpose, an environmental meter called BABUC-A, from the Italian company Lsi – Lastem, was used, which recorded all internal parameters, such as: air temperature, black sphere temperature, relative humidity, air velocity, CO_2 concentration. The meter was placed in the center of the lecture hall. The device was in operation for the entire duration of the study.

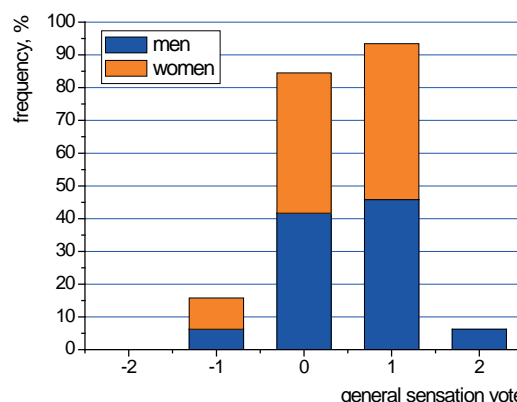
ca. 10% of women and 6% of men were not satisfied. As a consequence, it can be stated that the parameters of indoor air were properly selected and led to the positive feelings of the students, despite high air temperature and carbon dioxide concentration.

Fig. 5. General sensations of the students in the large lecture room
