STUDY OF THE CONDITION OF THE SELECTED LANDSLIDES IN THE AREA OF KADZIELNIA

The Kadzielnia nature reserve located in Kielce is a remnant of the long-term exploitation of limestone. The slopes of a former quarry are unstable; landslide processes occur there, posing a threat to humans and disturbing the landscape. This condition requires observation of the changes in order to take preventive measures. The article presents the preliminary results of such observations, performed for four selected landslides in Kadzielnia. While measuring, modern geodetic techniques were applied, including satellite technology, scanning tacheometry and laser scanning. Obtained results indicate slight displacements of the monitored walls over several months. Observations which were made are initiating study on the behavior of the landslides in the area of Kadzielnia, aimed at early detection of threats and enabling taking safety procedures.

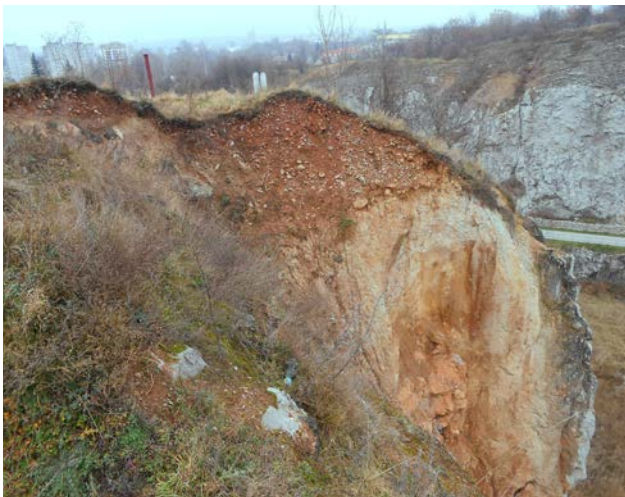
Fig. 2. Surface of the cut [2]

In accordance with the classification of the landslides [7-9], the landslides studied by the authors, located in the Kadzielnia nature reserve, are insequent landslides, formed when a landslide occurs across the structural surface. The surface of the cut partly belongs to the weathering area and partly runs along the surface of the cracks. Colluvium consists of a detrital and block material (comminuted ground, rock waste, rock boulders). Due to the almost vertical wall of the scarp, mass movement in the area of Kadzielnia can also be classified as tearing off. Figure 2 shows the surface of the cut, along which the material has slid. Figure 3 shows a fragment of the monitored area and the torn off material collected at the base of the scarp. In Figure 3 the cracks in the rocks can be clearly seen, along which in the future the cut surface may occur.

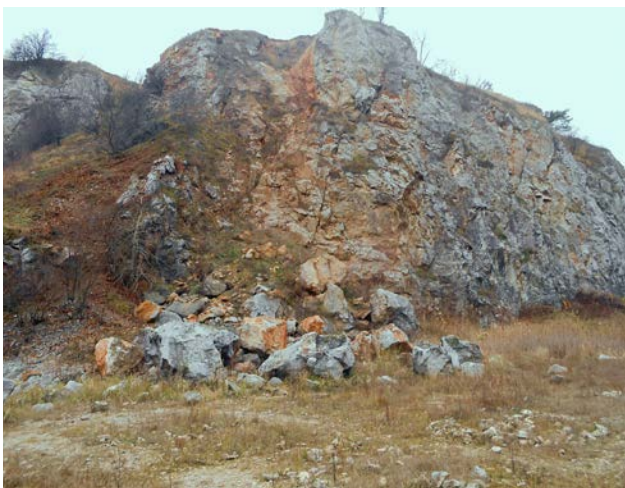
Fig. 3. Slid material at the base of the scarp [2]

In the light of the data presented above, the studied object can be classified as translational landslide.

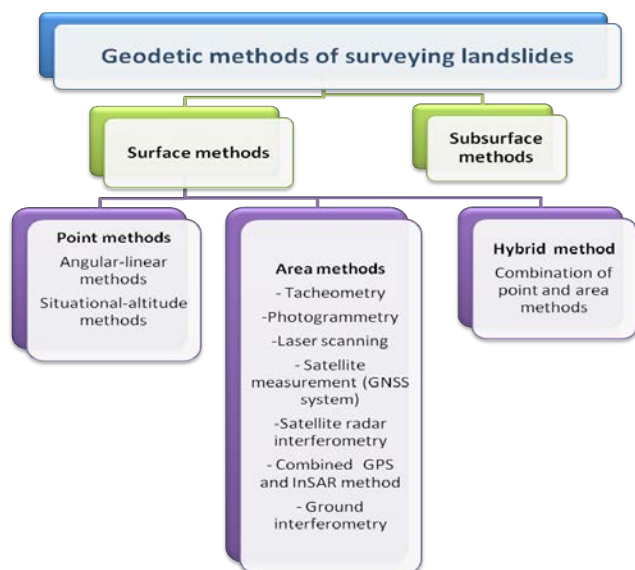
Fig. 4. Geodetic methods of surveying landslides (according to: [10], [11])

For the assessment of landslide movements, their size, direction and speed, quantitative information resulting from cyclic measurement is essential. Its purpose is to determine the extent of the landslide, speed and direction of its movement. Geodetic monitoring methods are put into two main groups: surface – related to surface movements of the landslide and subsurface [10-11]. The detailed division is shown in Figure 4.

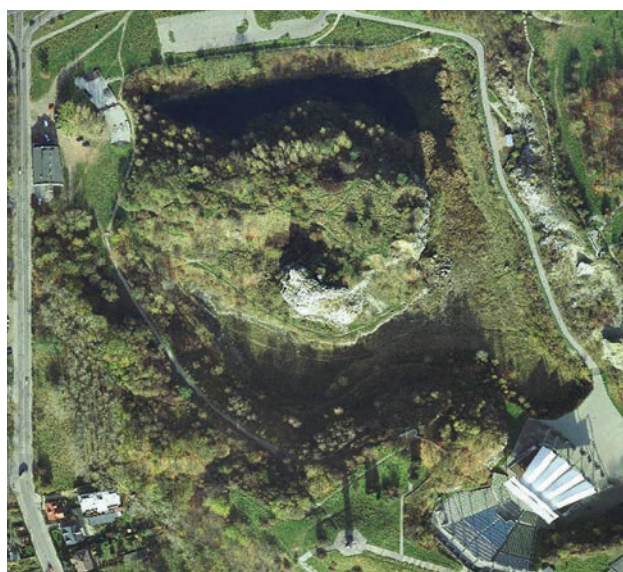
Fig. 5. The map of Kadzielnia showing the distribution of stabilized measuring control points [1]

In the case of the Kadzielnia reserve four metal poles were fixed in the ground, playing the role of control points. Stabilization was performed using two 2-meter poles with a diameter of 20 cm with a thread (to enable installation of the mirror and setting the instrument without using a tripod, i.e. with forced centering), and two 1.5-meter pipes with a diameter of 8 cm which enable the installation of a mirror, but without the possibility of setting an instrument. The sketch of the control network is shown in Figure 5.
