# THE FEASIBILITY ASSESSMENT OF THE EXHIBITION HALL AFTER THE FIRE

The article presents the feasibility assessment and evaluation of technical conditions of basic structural elements of exhibition hall after the fire. The aim of this investigation was to develop the ways for further exploitation of the structure and to evaluate the extent of repairs to be done. The scope of investigation and the detailed methodology for the investigation is presented. Given is the impact of the fire load on the bearing capacity of structural elements. To assess the impact of the damages on the main load bearing beams, besides the standard tests, also the acoustic emission (AE) method was applied.

The subject of this investigation is the construction of the exhibition hall F/G. It is built in the exhibiton complex named Kielce Fair.

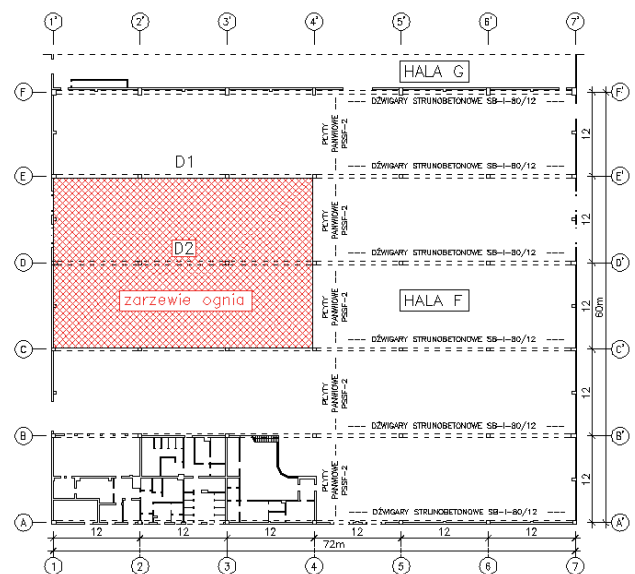
Fig. 3. The ground floor plan of exhibiton hall F

The fire was discovered in the exhibition hall F. Its origin was localized in the area between the axes C-C’/E-E’ oraz 1-1’/4-4’ (Fig. 3). The fire did not jump directly on construction elements. They were fire resistant. However it moved through installations, mainly electrical wires and the exhibition items on display. It took about 3 hours to extinguish the fire.

In the area of fire ignitron (Fig. 3) many cracks were discovered in prestressed concrete girders. Cracks were characteristically inclined, running from the support of bearing plates towards their suspension in both directions with 30-60° angles. They were noticed on 4 bearing plates. Besides, on the lower shelves of girders, net fracturing of concrete over its entire surface into the web, was observed (Fig. 4).

In the remaining part of the exhibition hall the cracks in girders were occasional and they appeared mostly in the areas of support. Similarly, in areas between the axes C-C'–E-E' and 1-1'–4-4' the bearing plates were severely damaged. On the surface of the plates visible were the cracks and scratches. They were also present in their middle and in the corners. In the cracks one could observe the remains of the asphalt binder migration coming from the roofing. Besides, in the ribs connecting the bearing plates, the movements of the plates and injections of the asphalt binders were seen. This occurred not only in the fire zone, but also on the plates which were placed away from this zone, particularly in the vicinity of exhibition hall G.
